1991 STUDY

1991 HAMILTON  
TRAFFIC OPERATIONS  
STUDY

CITY OF HAMILTON, MONTANA

MARVIN & ASSOCIATES

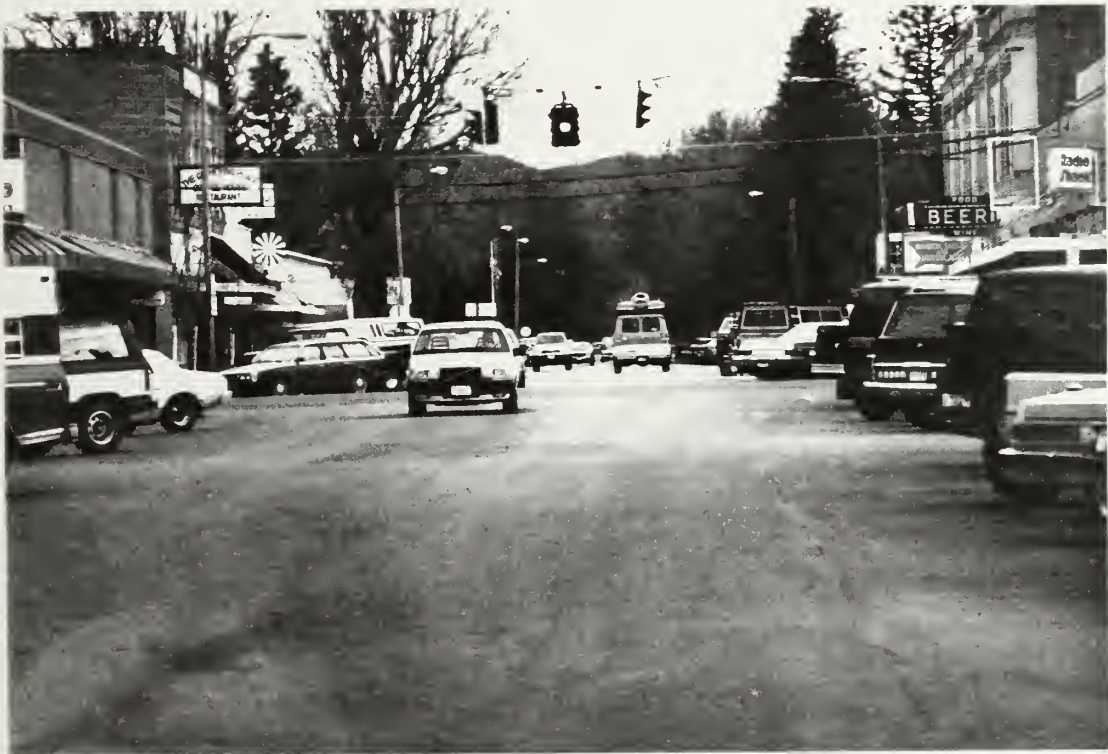
A span wire mounted signal installation exists at the intersection of Second and Main. There are four signal heads, one for each approach. The exact type of controller is not known because it is mounted on the roof of an adjacent building. It operates on a fixed time 60 second cycle. There are no pedestrian indications, which provides a guessing game for people walking up to the signal. Twenty four seconds are required for pedestrians crossing Main Street, while the green phase only allows 21 seconds. The lack of sufficient signal heads and pedestrian signals make this signal completely inadequate for the given conditions. The photo below show the southbound approach to this intersection.

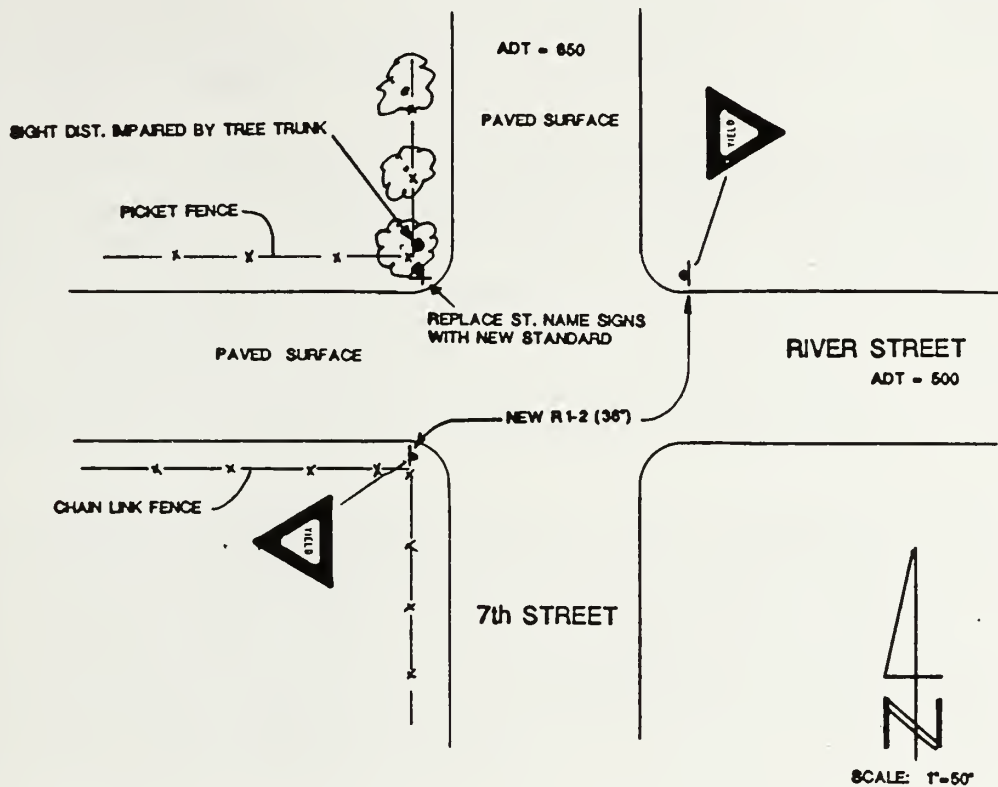
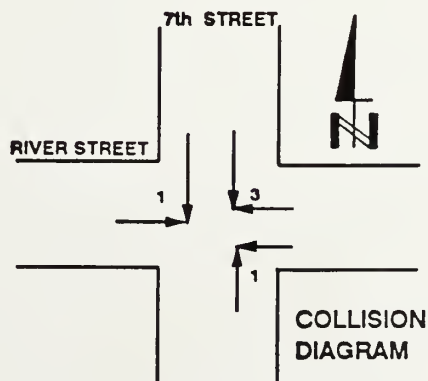
FIGURE NO.  
VI-1.

There were a total of 6 accidents in the reporting period at this intersection. They were all angle accidents. The most predominant accident were collisions involving southbound and westbound vehicles. Sight distance is somewhat impaired in the northwest corner and the lack of curb & gutter inhibits control of parking. Other than the possibility of vehicles parking too close to the intersection, there is no other obvious conditions contributing to the high accident rate. It is suspected that there may be confusion by drivers that one of the other streets is a through street.

In order to assist drivers in the decision of right of way and to effect some measure of control at this intersection, it is recommended that "Yield" signs be placed on River Street and new larger white on green street name signs replace the existing black on white signs to aid drivers unfamiliar with the area (20% of drivers were from out of town). This recommendation is for the short term. If accidents persist, stop signs should be considered. The Police Department should also monitor this area for corner parking violations (see "General Recommendations).

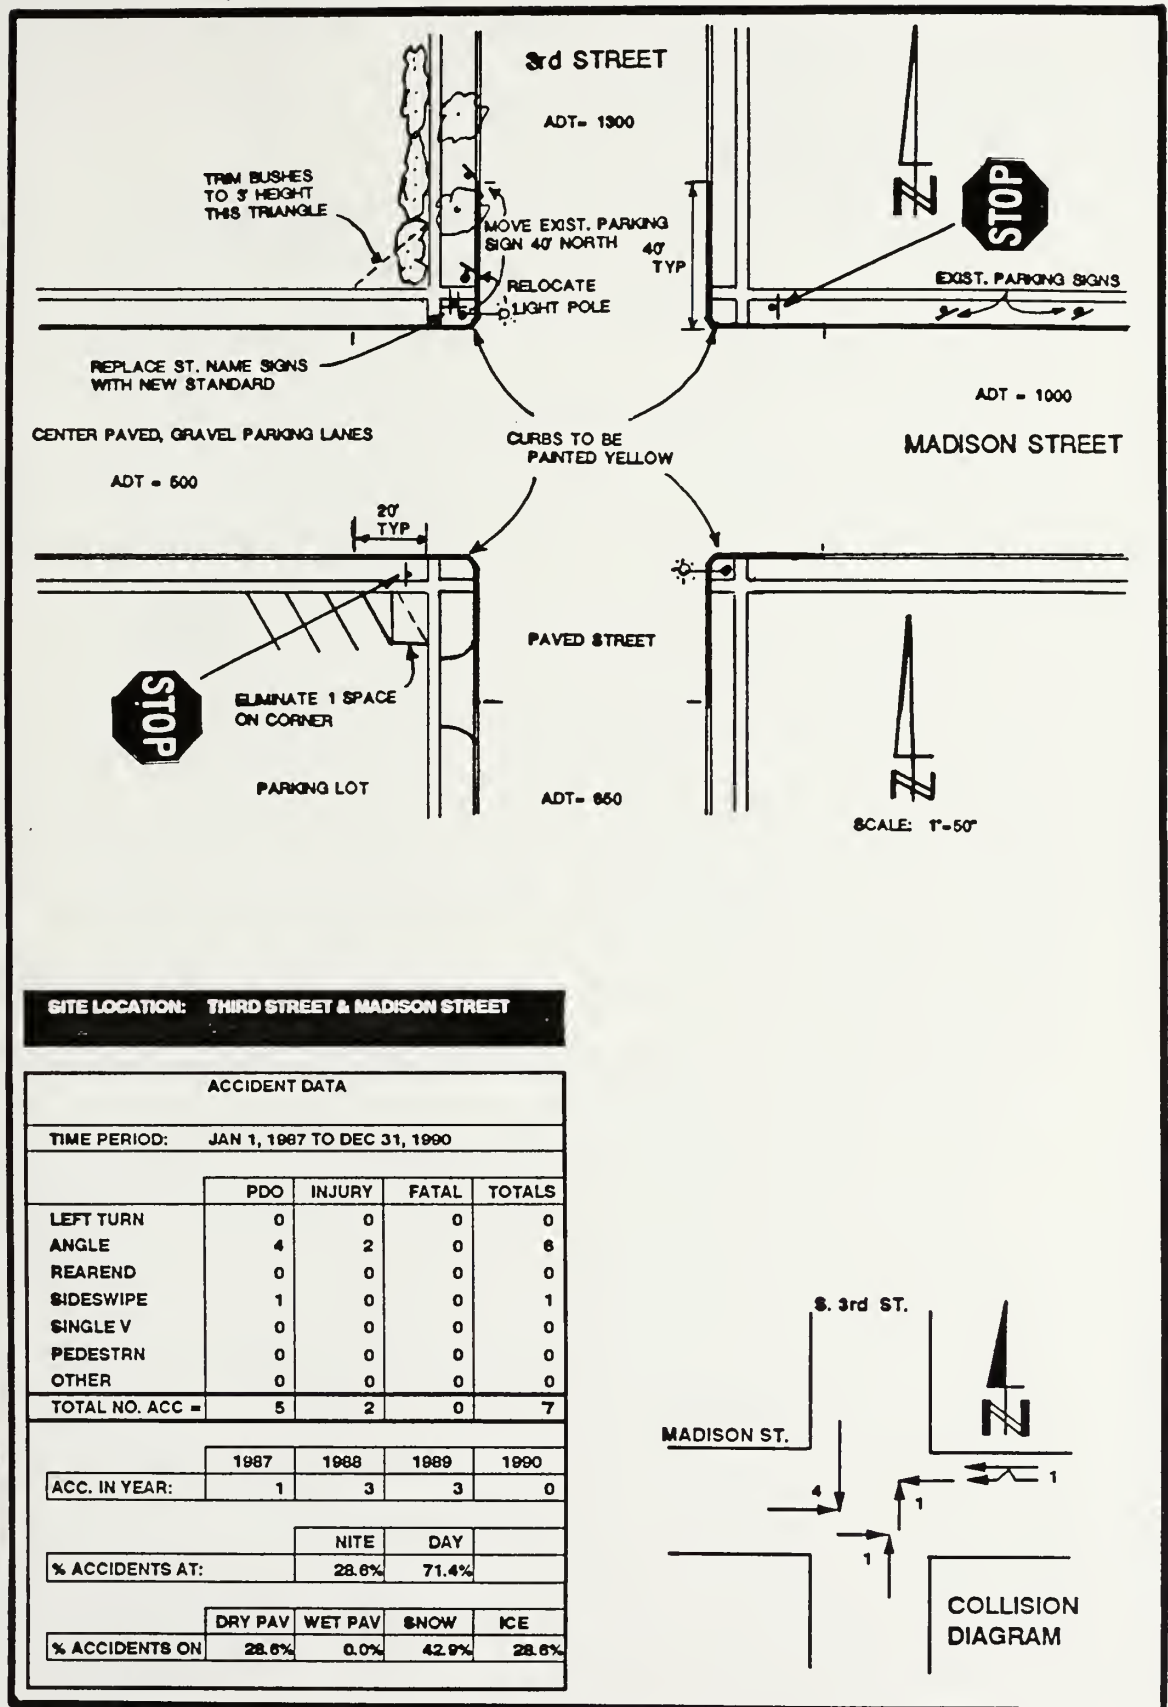
FIGURE NO.  
VI-2

Figure VI-2. illustrates existing conditions and recommended improvements at this intersection. Third and Madison is located on the fringe of the CBD and there is an imbalance between traffic volumes on the four legs of the intersection. A significant portion of the traffic is circulation traffic and not thru traffic. Curb & gutter exists on all legs while parking patterns are mixed. Third street, north of the intersection, has angle parking on the west side. All other streets have parallel parking. There is an off street parking lot, which is located in the southwest corner of the intersection.

The curb & gutter should be marked for no parking by painting them yellow as indicated. One space in the parking lot should be removed to improve the line of sight. Bushes in the northwest corner should be trimmed so that they do not exceed a height of 30" as measured from street elevation. The light pole in the northwest corner presents a hazard, as it is too close to the road and should be move north. Parking signs must be relocated to comply with the corner restrictions and the street name signs should be replaced with the new standard white on green. Implementation of these improvements should provide aesthetic as well as potential safety improvements.

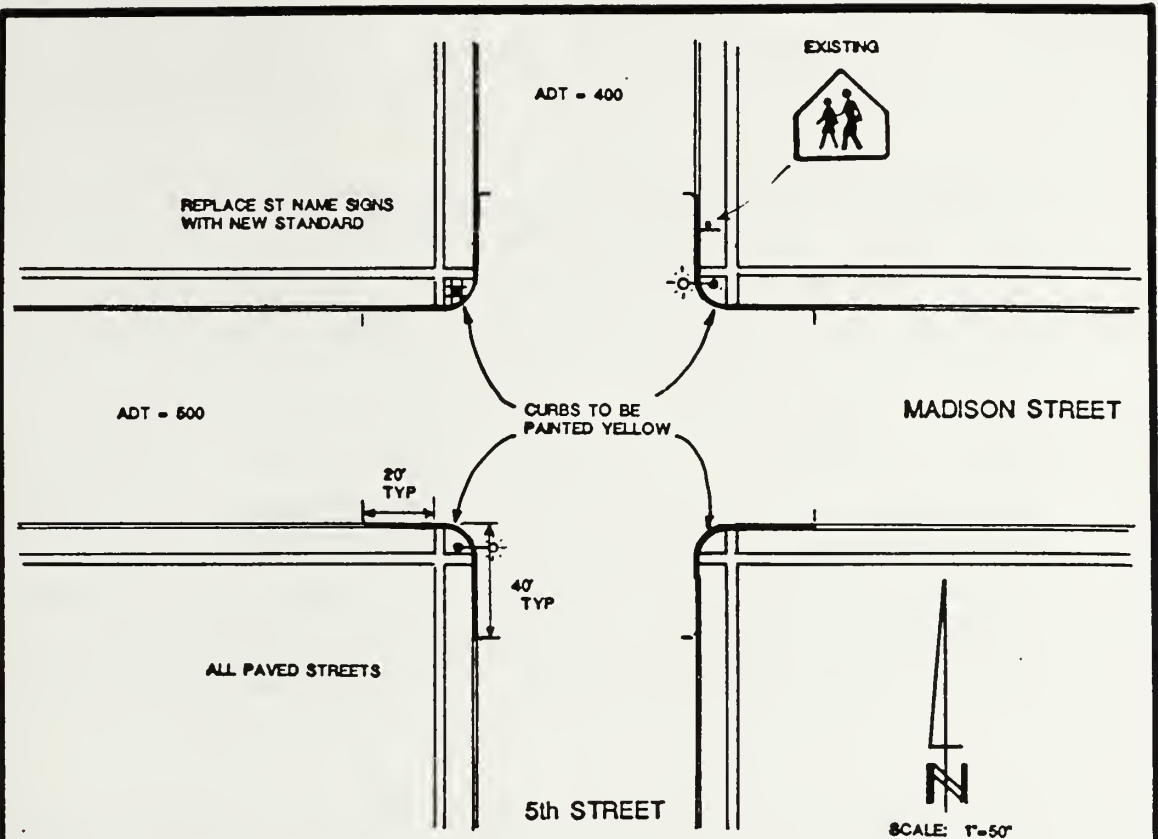
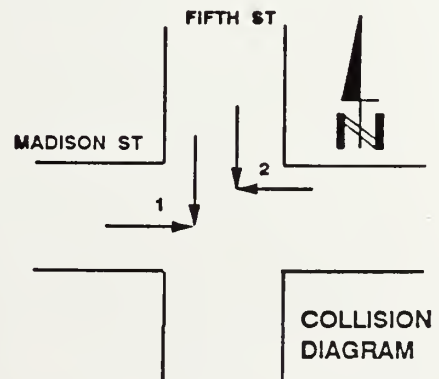
FIGURE NO.  
VI-4.

There were 3 accidents in the reporting period. All of them were angle accidents involving southbound vehicles. No other contributing circumstances could be found other than a temporary loss of the line of sight.

Correct parking restrictions should be marked at the corners by painting the curb yellow as indicated on the drawing. Further control of the intersection does not seem feasible at this time. If the accident problem continues, after parking restrictions and police monitoring has been implemented, yield control should be considered. As at most other intersections in Hamilton, the street name signs should be upgraded.

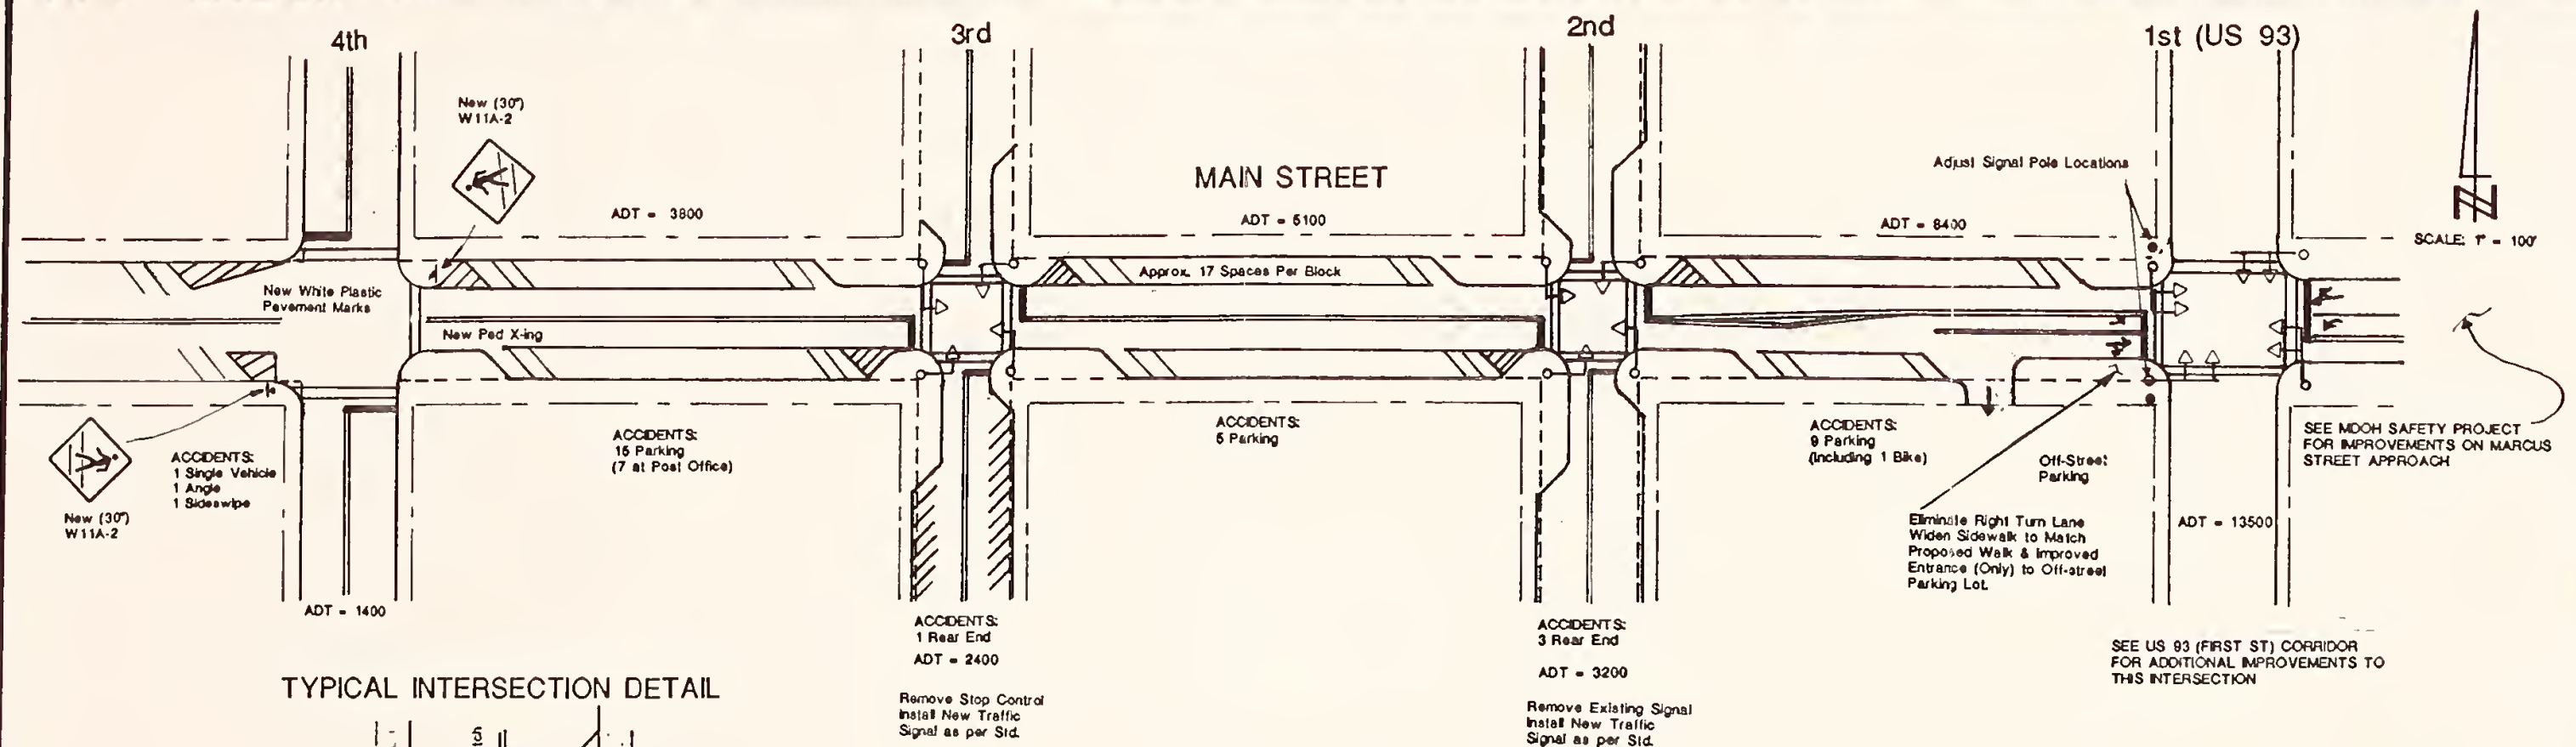
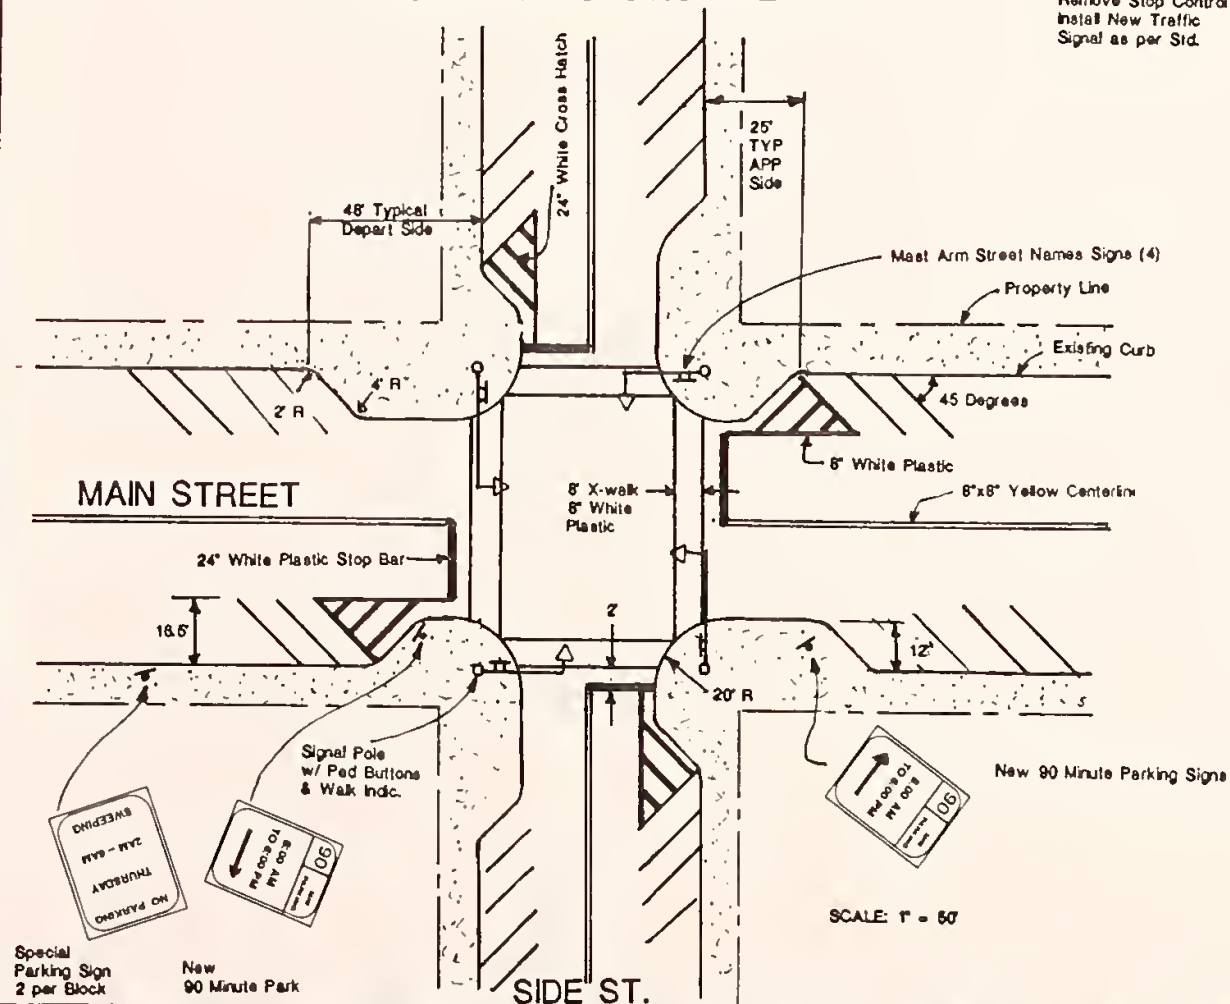
Accidents within this corridor involve both mid-block and intersection accidents, which are summarized in Figure VI-6. The corridor accident statistics do not include the First Street intersection, since it is covered in the US 93 Corridor section. A brief look at the accident statistics provides a fairly clear picture of the problems encountered. Twenty six of the 32 accidents occurring within a block distance, were accidents involving parking maneuvers. The others, rear end, angle and sideswipe accidents, may have been indirectly related to angle parking. A normal urban street with an ADT in excess of 8,000 and signalized intersections should experience a higher rate of rear end, angle and sideswipe accidents and very few parking accidents. The reason that typical accidents are not as high is probably because traffic flow is severely inhibited by parking maneuvers and thus potential conflicts are avoided by slow speeds.

Traffic signing on Main Street is of particular concern. Many unnecessary signs exist at present and many signs are ineffective or would become ineffective when the proposed project is implemented. It is therefore recommended, that all of the existing signs be removed and salvaged if possible. New signs would consist of parking restrictions, special parking conditions, street name signs and warning signs as detailed in Figure VI-6. Large mast arm mounted street name signs on new signals are as vital as most regulatory signs in preventing accidents.

Two new traffic signal installations are recommended as a part of this improvement project. The existing signal at Second does not meet any of the current standards for traffic signal operation and is probably more hazardous than no signal at all. The lack of pedestrian indications creates a guessing game as to when the light turned green and how much time there is left to cross the street. Existing signal timing allows a marginal amount of crossing time even when the start of green is noticed. New signals would provide proper pedestrian indications working off a fixed time coordinated system. Optimized timing would be enhanced by the shorter crossing distance created by the proposed end islands at the intersections.

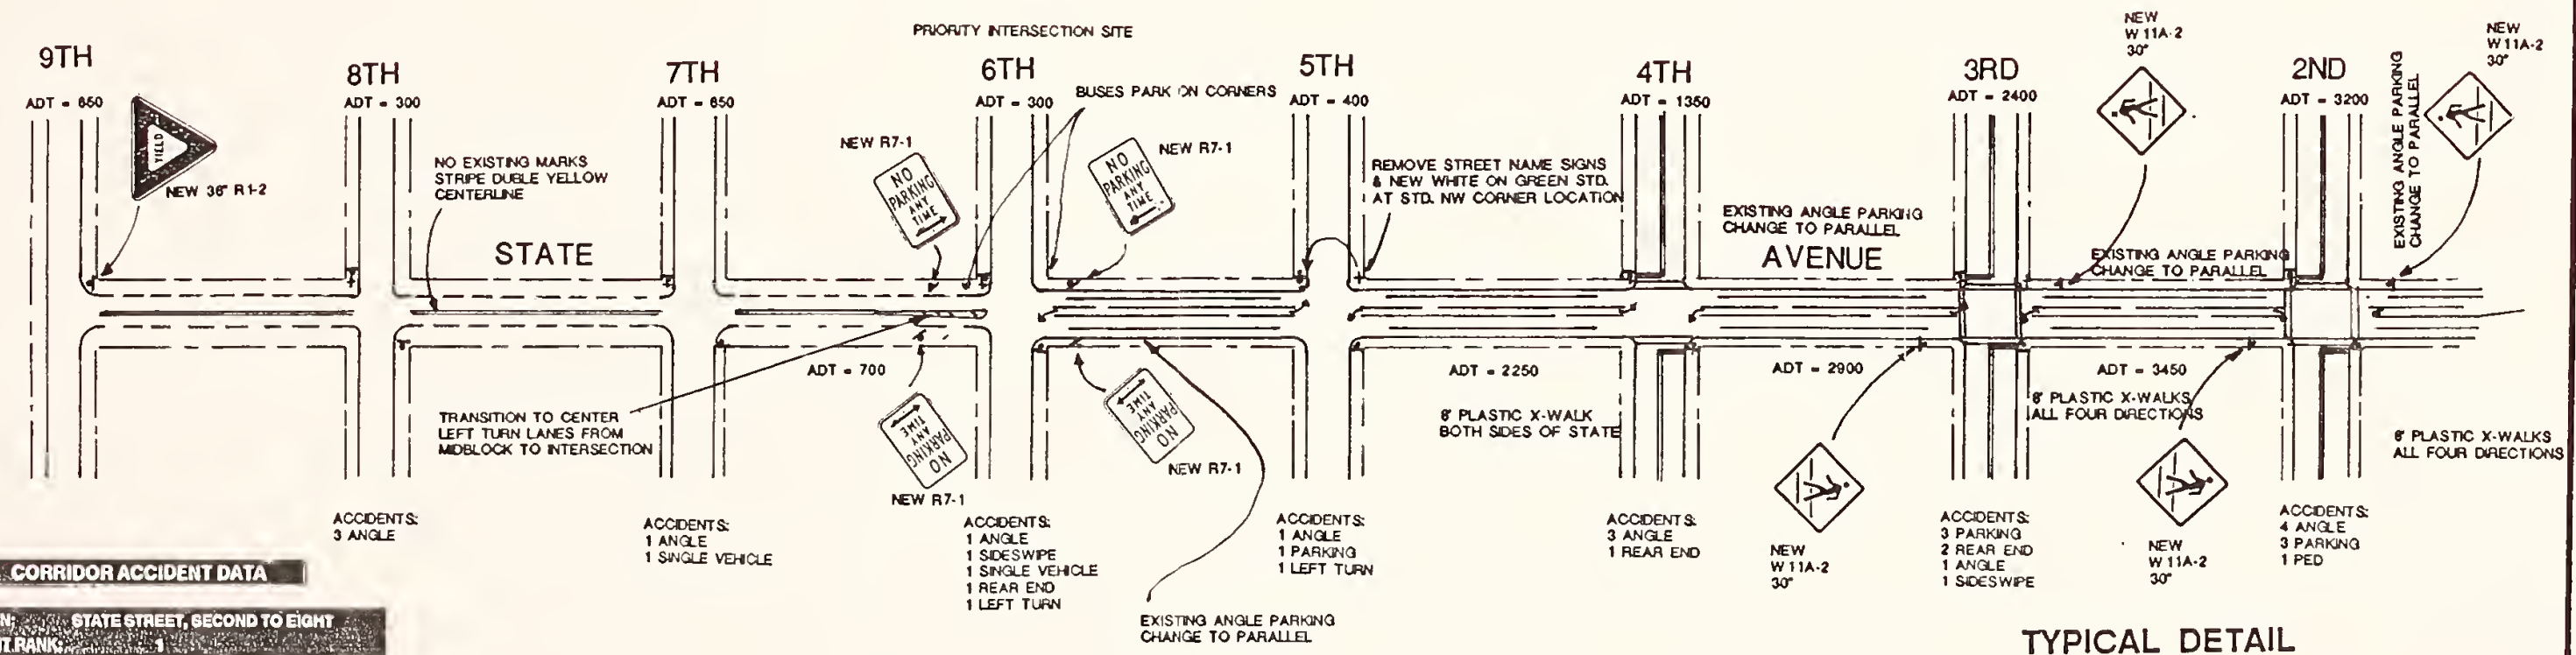
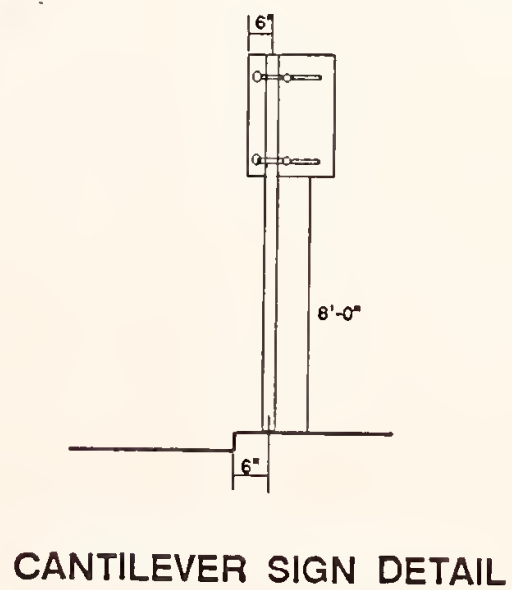
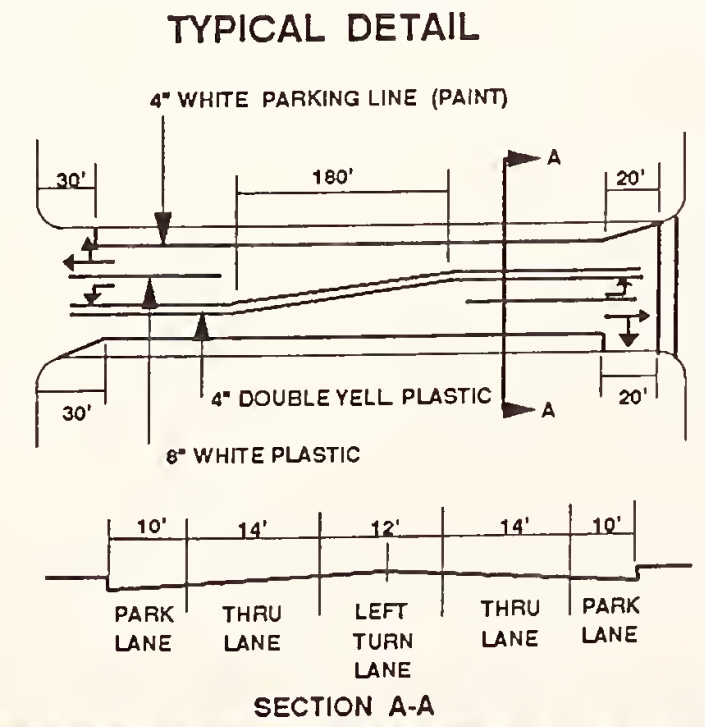
Traffic observations on State Street indicated that street side parking is currently under utilized with no more than 50 % of the spaces occupied during three observation periods. Because of the apparent lack of demand, conversion to parallel parking along the entire length of State Street should not create significant parking problems in the CBD. This action would enable implementation of the recommendations shown in Figure VI-7. State Street east of 6th Street could be marked as a three lane street, providing left turn lanes at intersections and in some cases, to mid-block approaches. Significant accident reductions along State could be realized by this action. However, other aspects the proposed project would be required for proper operation. Signing improvements would be required to insure proper installation and visibility of necessary signs. Pavement markings should be inlaid plastic to maintain a long useful life. Not

shown on the sketch are turn lane designation signs that may be required depending upon the final configuration of the left turn lanes, which may be continuous through each block or provided by transition bays.

All legal parking restrictions, as detailed in this report, should be marked by yellow paint on curbs or by signage in special cases. The intersection with 6th Street is commonly blocked by school buses waiting at the High School. In this case, signage and enforcement is required to keep the intersection clear.

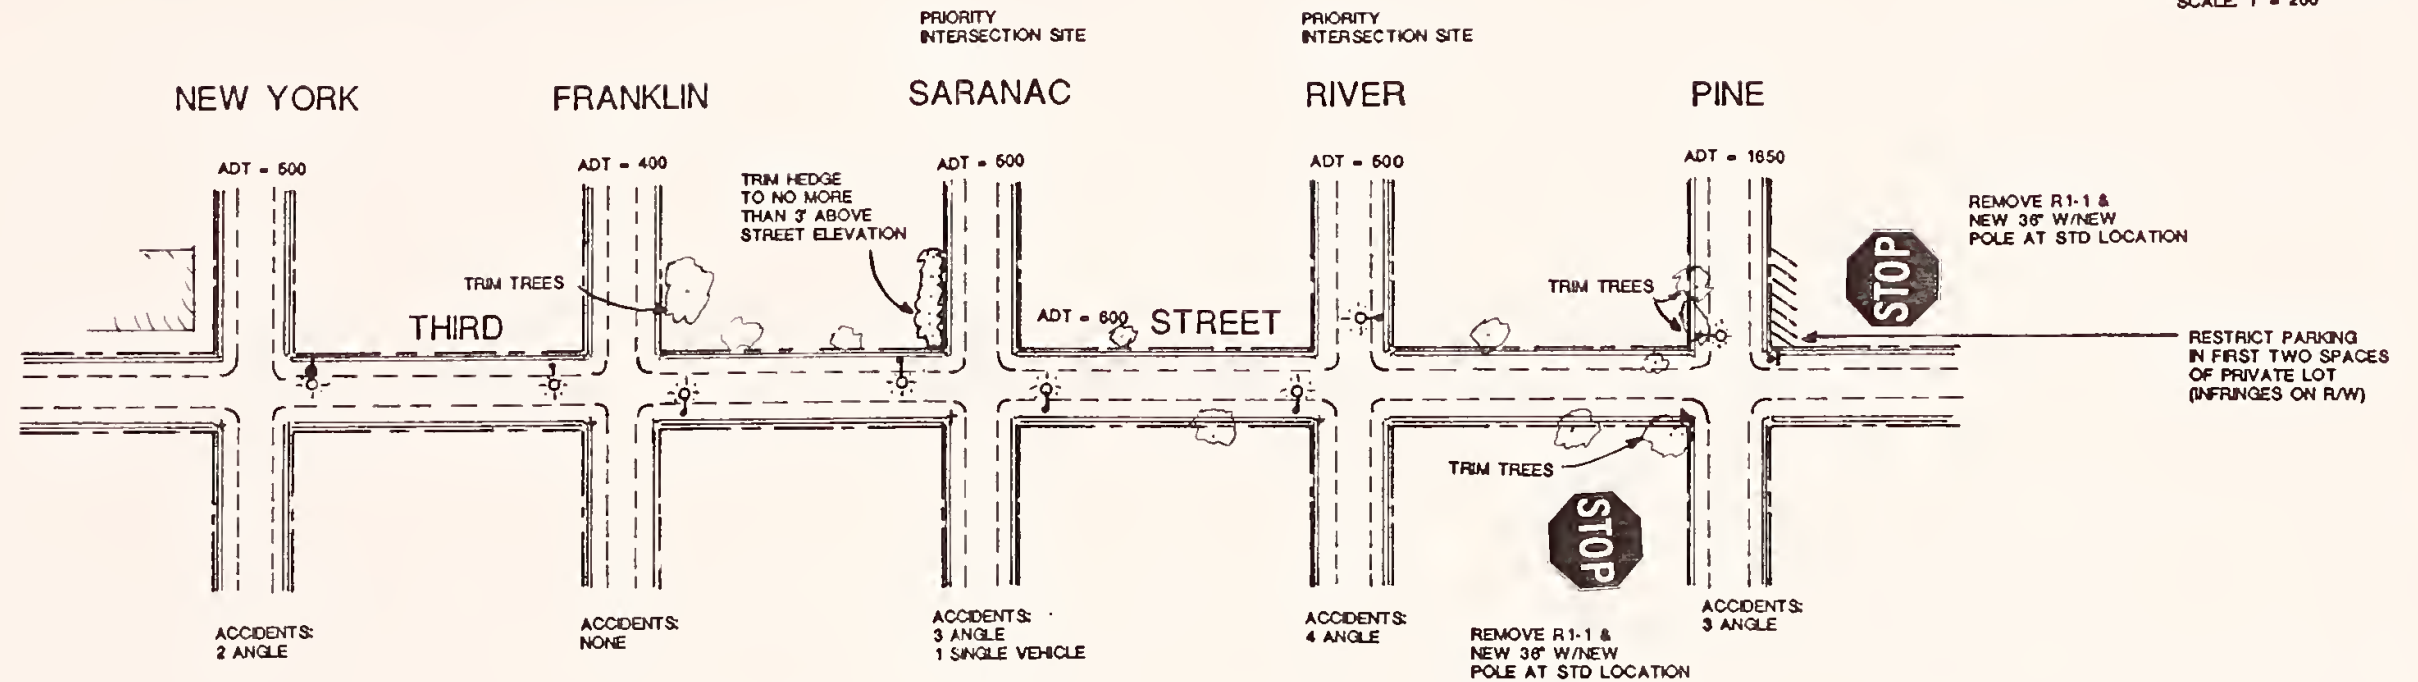
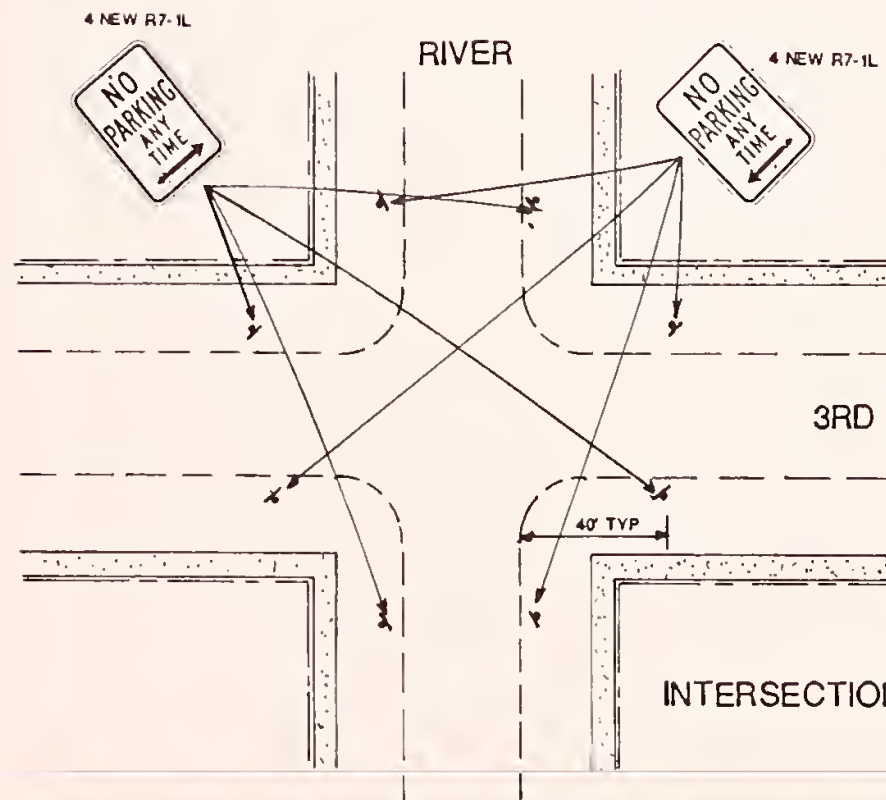
During observation periods, very few permanent sight distance restrictions were noted. The improvement sketch, Figure VI-8., indicates the locations where sight restrictions exist. Trimming of low branches on tree and high branches on shrubbery should take care of those areas. A parking lot in the southeast corner impedes sight distance. The intersection clear zone should be protected by eliminating at least 2 of the corner spaces. The only other possible controls that could be instituted would be

placement of larger stop signs at Pine Street and marking intersection parking restrictions as per state law and standards contained in the general recommendations section of this report. If residents of this area persist in parking perpendicular or at an angle, intersection restrictions must be also be increased. Periodic enforcement of the parking restrictions as described in the general recommendations section will be required to maintain the intersection clear zones. Neither function nor traffic volumes would warrant any other intersection controls in this area.

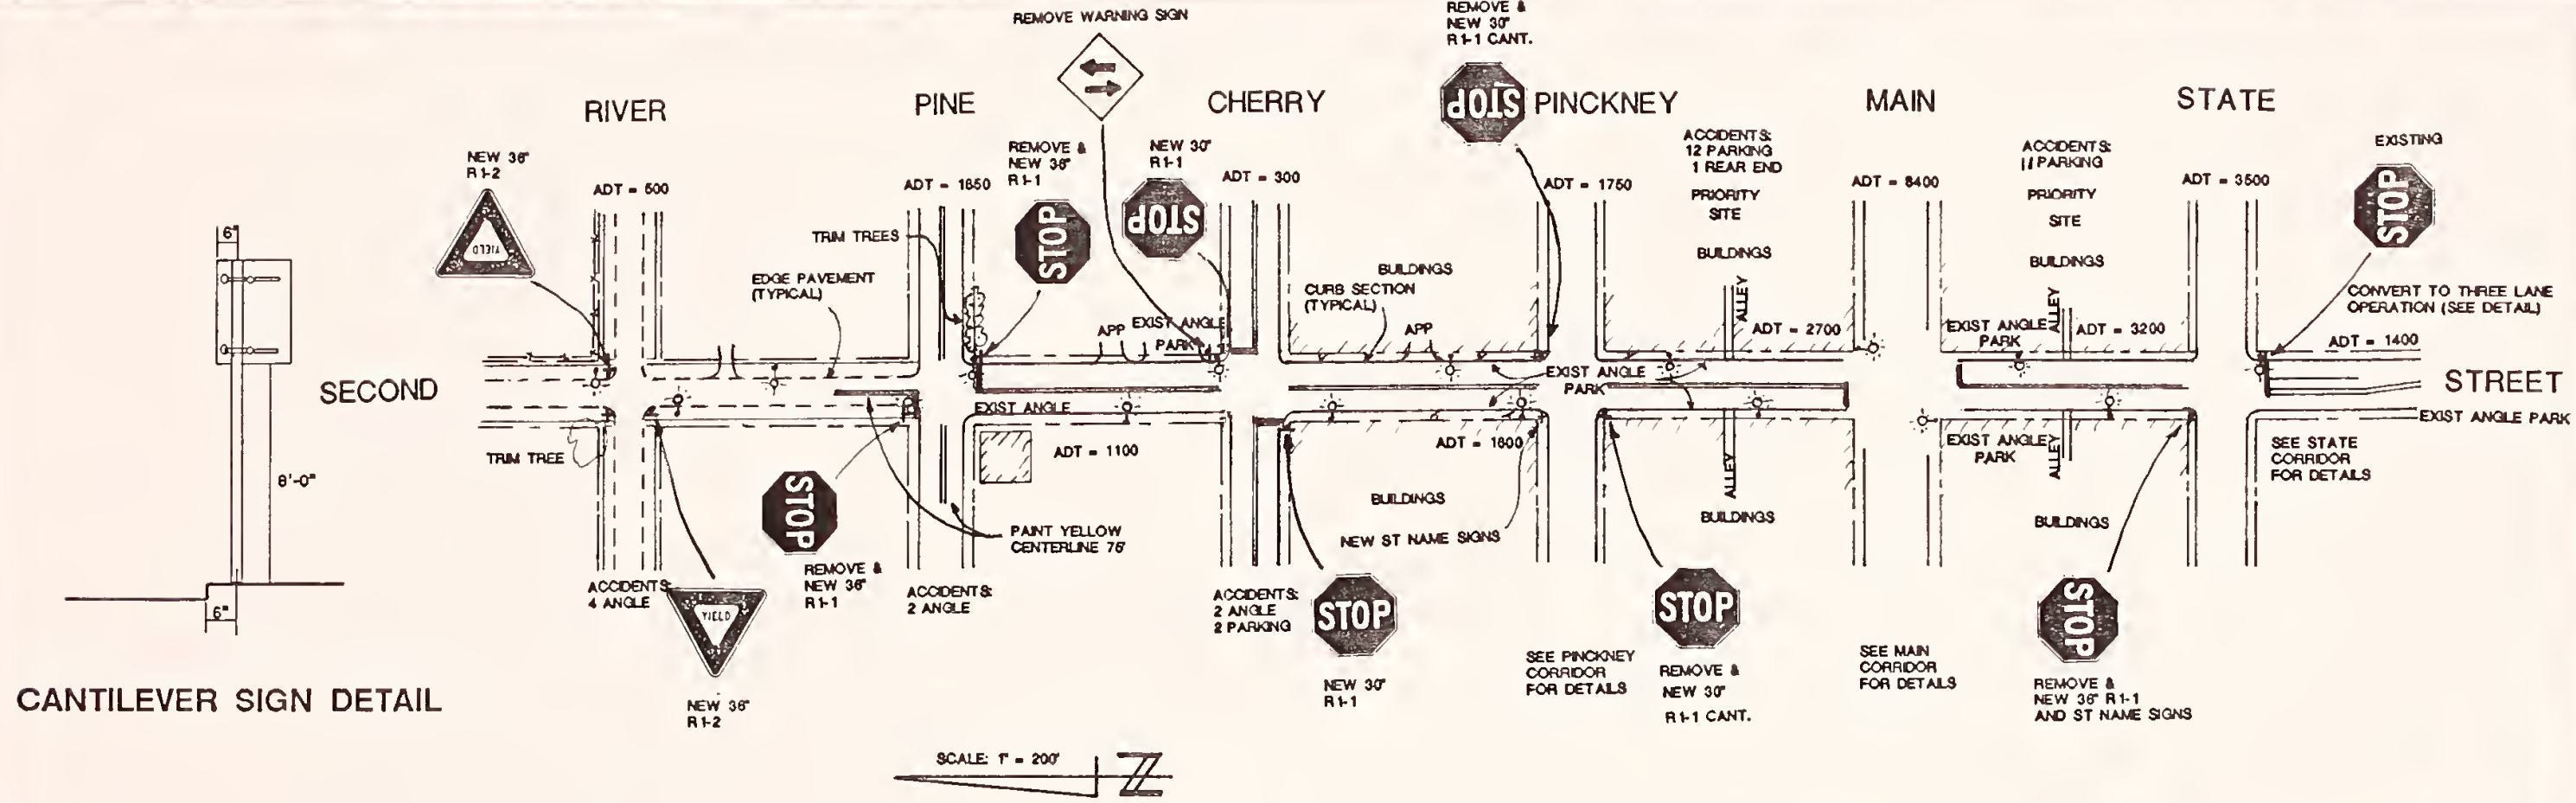
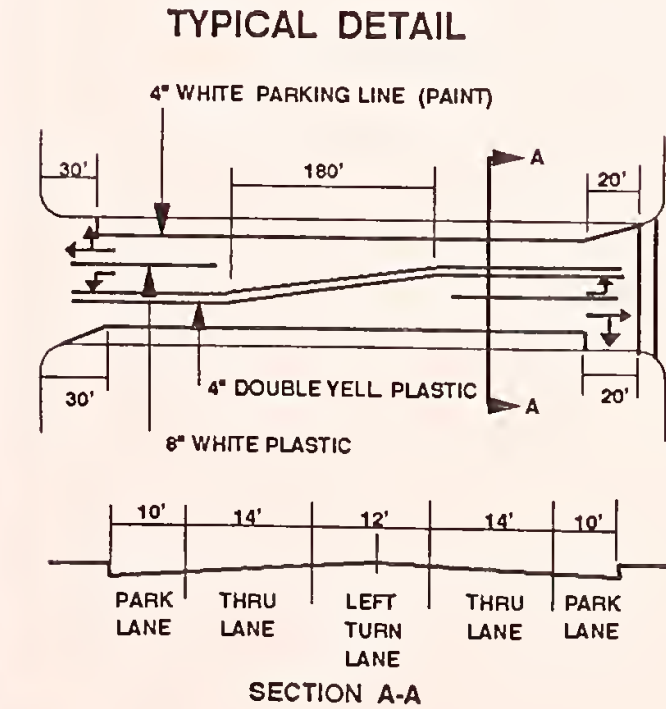
Street geometry and traffic controls vary dramatically throughout the 0.9 mile length of this corridor as well as the number of accidents and accident types. Figure VI-9., represented on the following two sheets, indicates the street geometry, traffic volumes, accident data and proposed improvements. Because of the dramatic change in street character and traffic operations along the corridor, the type of improvements also vary through out its' length.

Of all stop controlled intersections in Hamilton, the section between Madison and State Streets causes the most confusion. The assigned right-of-way control is proper according to traffic volumes, however a deep cross drain on either side of Bedford Street makes it difficult to maintain travel speed along Second. Vehicles slow, to near stop condition, to cross the drainage swail and Bedford traffic, waiting at the stop signs, interpret this maneuver as an indication that it is a four way stop. The result is a noticeable amount of stutter starts and near accidents. In this case, it is recommended that the cross can be reconstructed to provide a higher, more comfortable speed for vehicles crossing. This situation occurs at several other intersections in Hamilton and should be evaluated further.

Existing signing along this section of Second Street consists of parking control signs and stop signs, as well as one warning sign, the intent of which cannot be determined. Many parking signs will be relocated when parking restrictions are implemented. Signs which specify time limits and street sweeping should be located at standard locations, as noted in the Main Street improvements. Handicapped and other special signs may be placed for individual spaces as required. All signs should be checked for mounting height and alignment to the street. Several existing signs are directed parallel to the street and cannot be read until it is too late. New stop signs as recommended in Figure VI-9., sheet 2, should be a standard cantilever mount, to project them as close to the street as practical.

Pavement markings should be installed as noted in the improvements sketch, since guides for vehicle alignment, in an area with angle parking and higher traffic volumes, is important. The street centerline aids drivers entering and leaving parking spaces by providing a line of perspective from which to judge vehicle positioning.

The new stop sign at Cherry Street is necessary because of accident experience and consistency along the through route. The yield sign at River is recommended as a first level of effort to change past accident experience. No obvious sight restrictions exist at this intersection, other than some low tree branches. Future monitoring of this intersection will reveal if stop control or other form of traffic device is necessary.

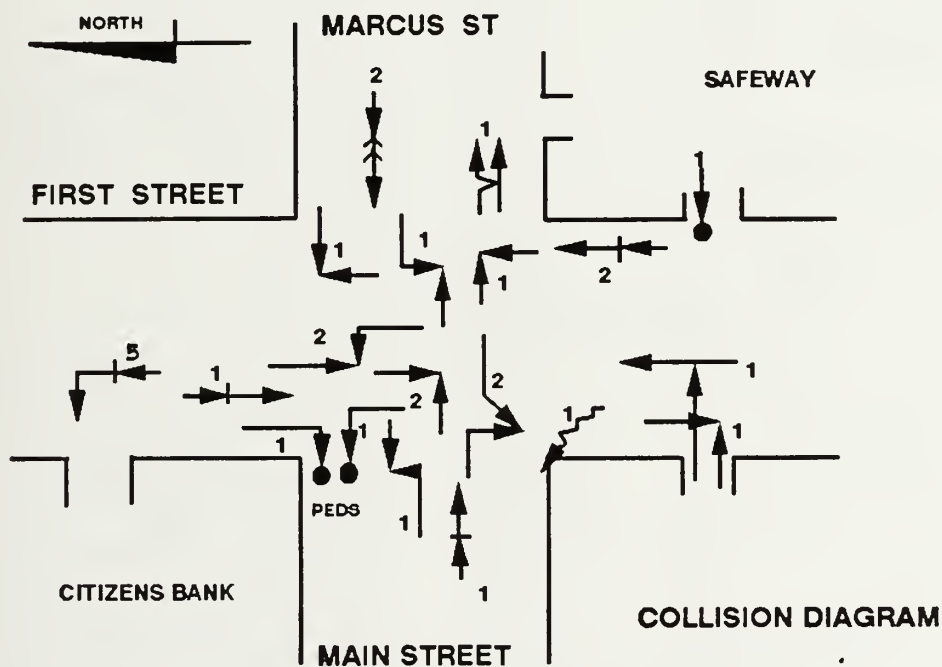
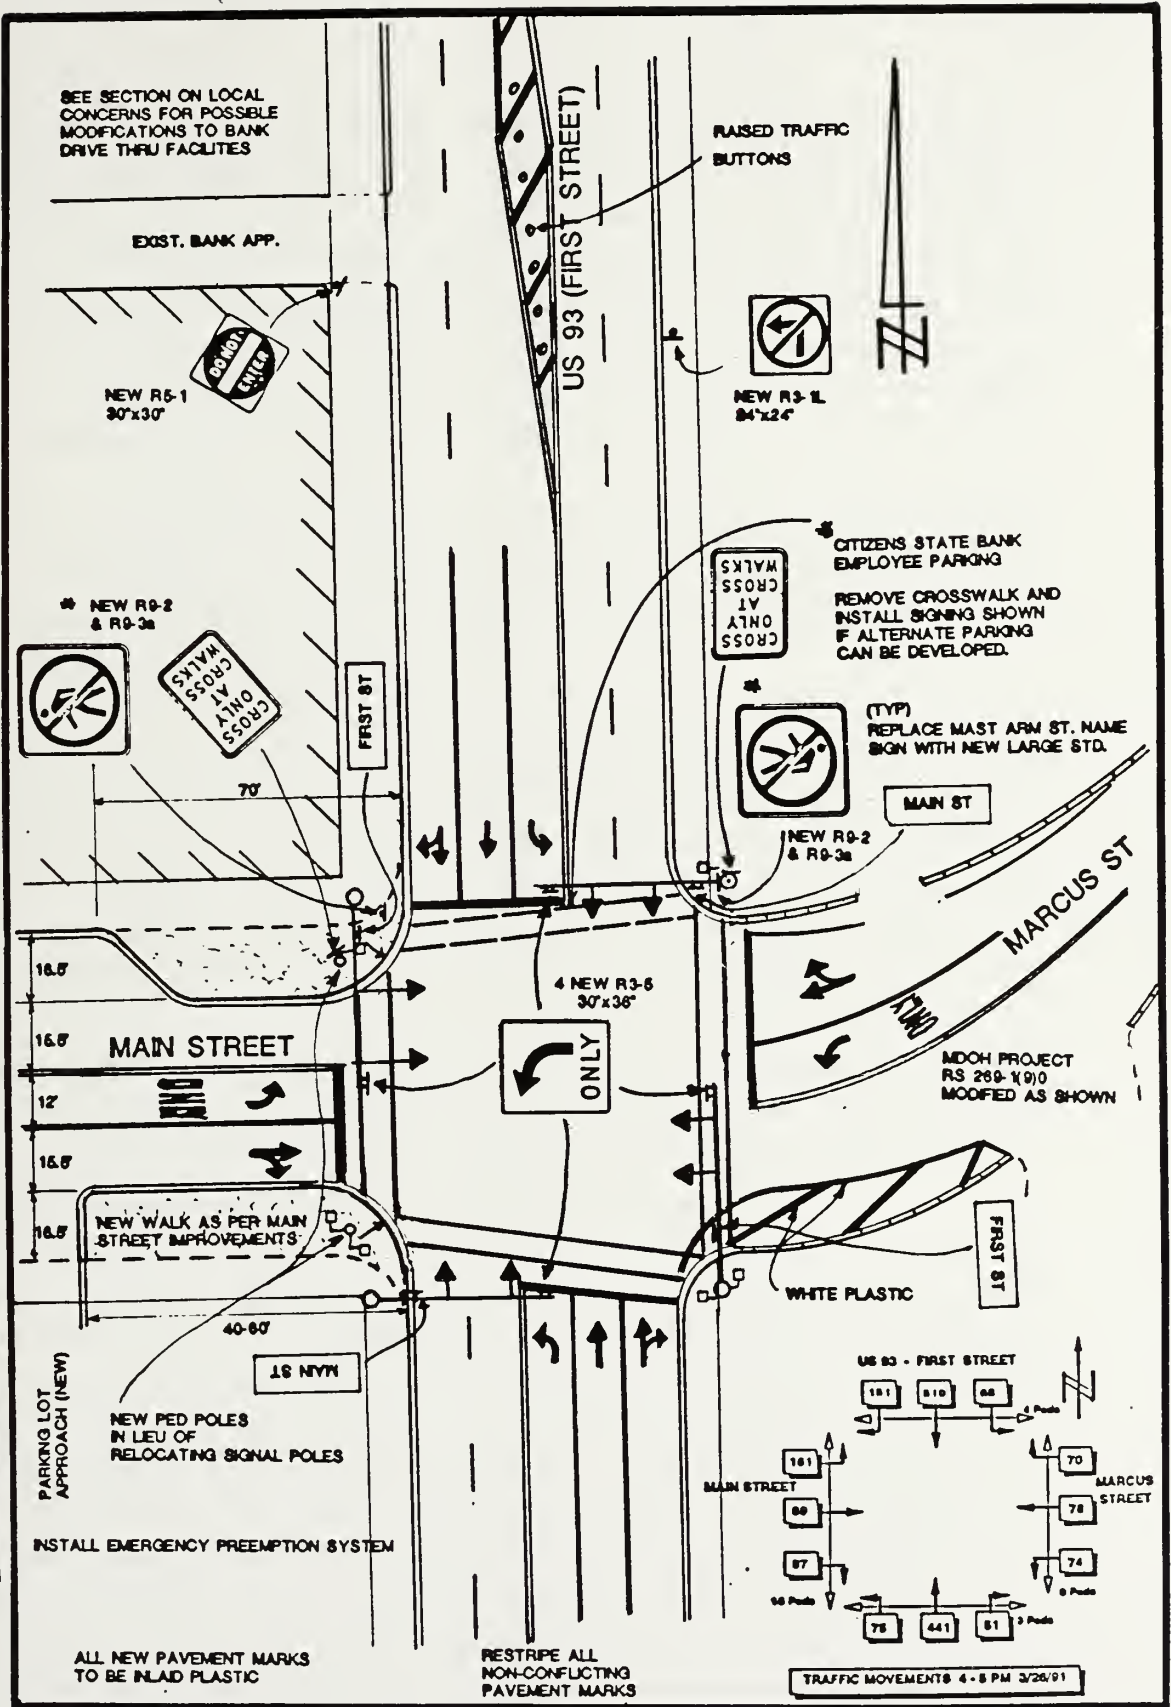
FIGURE NO.  
VI-11.

Another priority intersection along US 93 is at Main Street. In a four year period, there were twenty seven accidents at this intersection. The sketch presented below, indicates the wide variety of accidents that have occurred at this intersection. Some of the accidents, actually occurred at approaches near the intersection, such as the five left turn accidents involving the citizens bank approach. Also of particular concern were two pedestrian accidents. This intersection had a particularly high severity with 9 of 27 accidents producing injuries.

A significant number of accidents are directly or indirectly related to bad lane control and access control on the Marcus Street approach to the intersection. MDOH currently has a project being designed to eliminate many of these particular problems. During the analysis and evaluation of this intersection, it became apparent that there were other factors in the safety of this intersection, which were not being addressed by the MDOH project. Figure VI-11. is a sketch of the improvements being proposed through this study. The left turn to the Citizens Bank can be improved by eliminating the left turn from Main Street, by transitioning to a new left turn bay at Pinckney Street. Additional details regarding this improvement can be found in the Pinckney Corridor and the Local Concern section of this report.

The new Main Street Sidewalk project could be considered an ideal time to correct a problem at the Main Street approach to the intersection. The three approach lanes on Main, to US 93, are not needed in terms of capacity and the short storage area, often blocked by parked vehicles, is almost useless. At the same time, geometry of the intersection is such that opposing left turn drivers from Marcus cannot see right turning vehicles. It is recommended that the right turn be eliminated and replaced with a bulb island as shown. This would conform to the remainder of Main Street; provide a much shorter pedestrian crossing; and provide improved sight distance.

Mast arm mounted lane control signs are an obvious need at this intersection. During observation periods, approximately 30 % of the vehicles on the Marcus Street approach made inappropriate movements from the lane they occupied. Some violation of lane usage was also noted at all of the other approaches also.
